Additional test report of a fire resistance test utilising the general principles of BS 476: Part 20: 1987 on four specimens of wall and four specimens of floor mounted linear gap seals

173877

**Fischer Fixings UK Limited**  
Whitely Road  
Hithercroft Road  
Wallingford  
Oxon  
OX10 9AT

**Date: 30<sup>th</sup> May 2008**

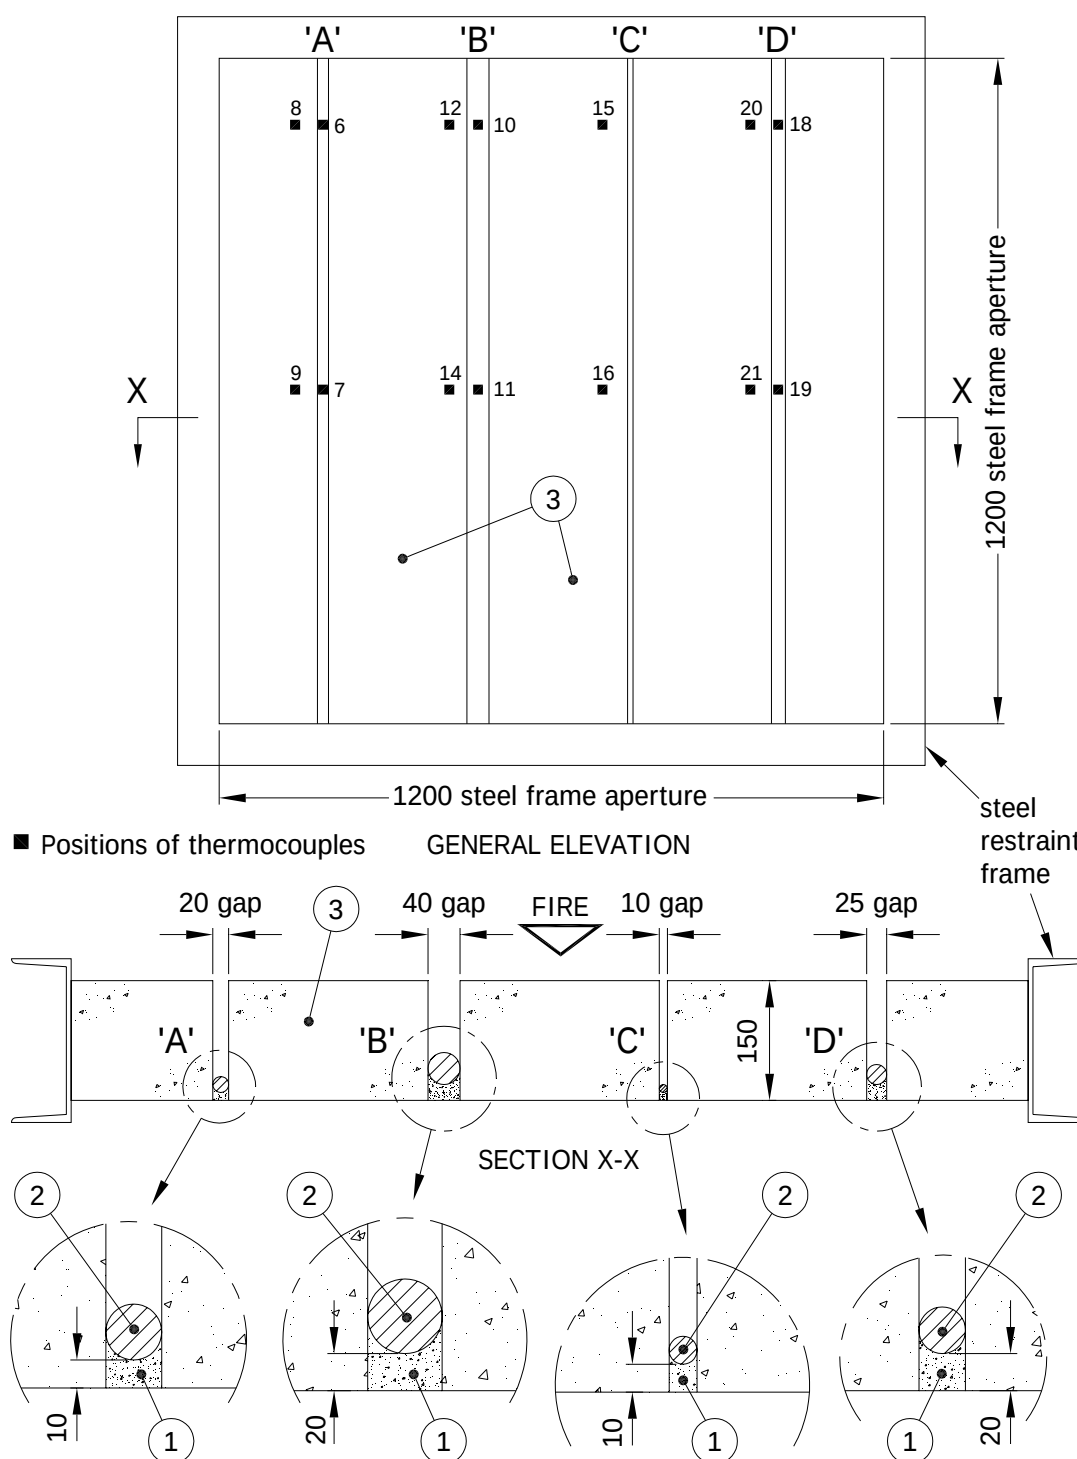
**Figure 1- General Elevation of Wall Specimens and Unexposed Face Thermocouples**

The section of wall had overall dimensions of 1000 mm long by 1000 mm wide by 250 mm thick and was provided with four linear joints, referenced Specimens A, B, C, and D. The section of floor had overall dimensions of 1200 mm high by 1200 mm wide by 250 mm thick and was provided with four linear joints, referenced Specimens E, F, G, and H.

| <b>Thermocouple Allocation</b> | <p>Thermocouples were provided to monitor the unexposed surface of the specimens and the output of all instrumentation was recorded at no less than one minute intervals as follows:</p> <p>At a minimum of two positions on the surface of the sealant material of each specimen, one nominally 100 mm from each end and one at mid span. All positioned at nominally mid-width.</p> <p>At a minimum of two positions on the surface of the wall and floor assembly, 25 mm away from the edge of each seal and adjacent to the positions of the thermocouples on the surface of the sealant.</p> <p>The locations and reference numbers of the various unexposed surface thermocouples are shown in Figure 1.</p> |

(Refer to Figures 1 & 2)

| <b><u>Item</u></b> | <b><u>Description</u></b> |
|---|---|
| i. Specimen 'A' & 'E' | : 20 mm x 10 mm |
| ii. Specimen 'B' | : 40 mm x 20 mm |
| iii. Specimen 'C' | : 10 mm x 10 mm |
| iv. Specimen 'D' | : 25 mm x 20 mm |

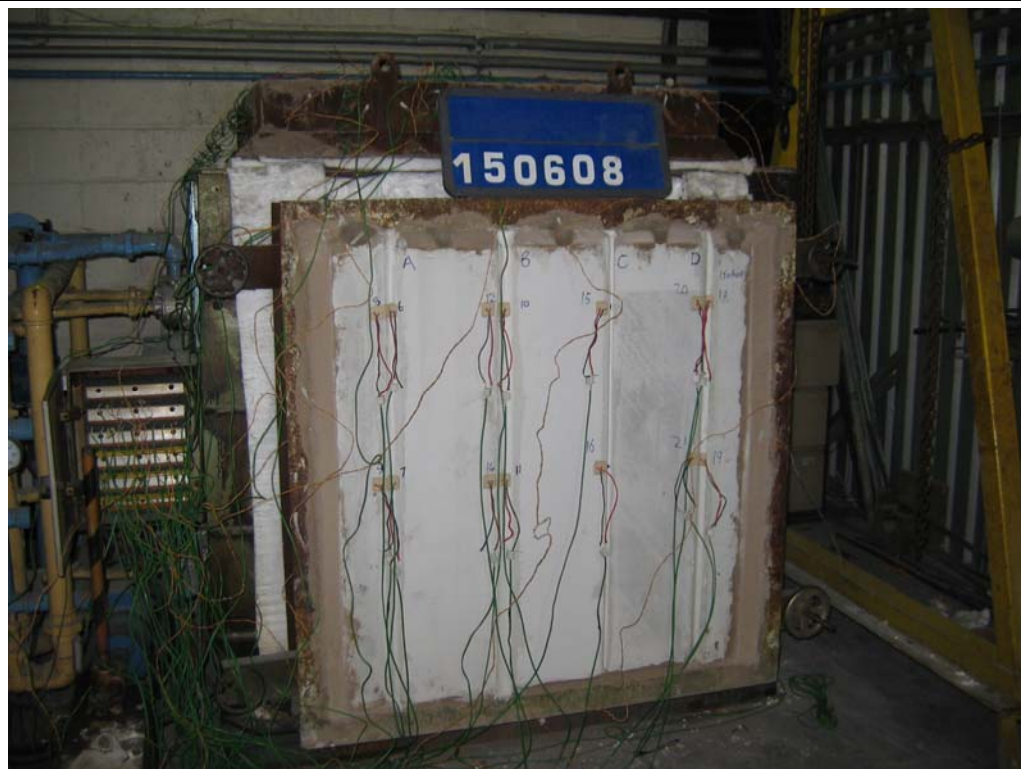
The unexposed  
face of the wall  
construction  
prior to testing

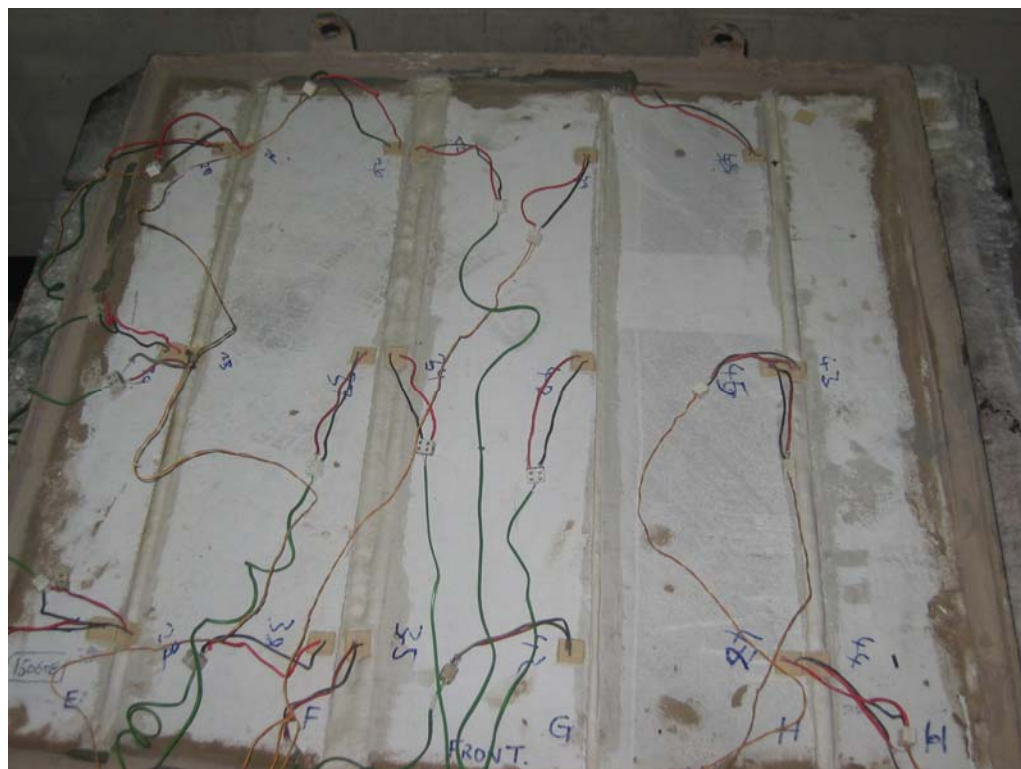
The unexposed  
face of the floor  
construction  
prior to testing

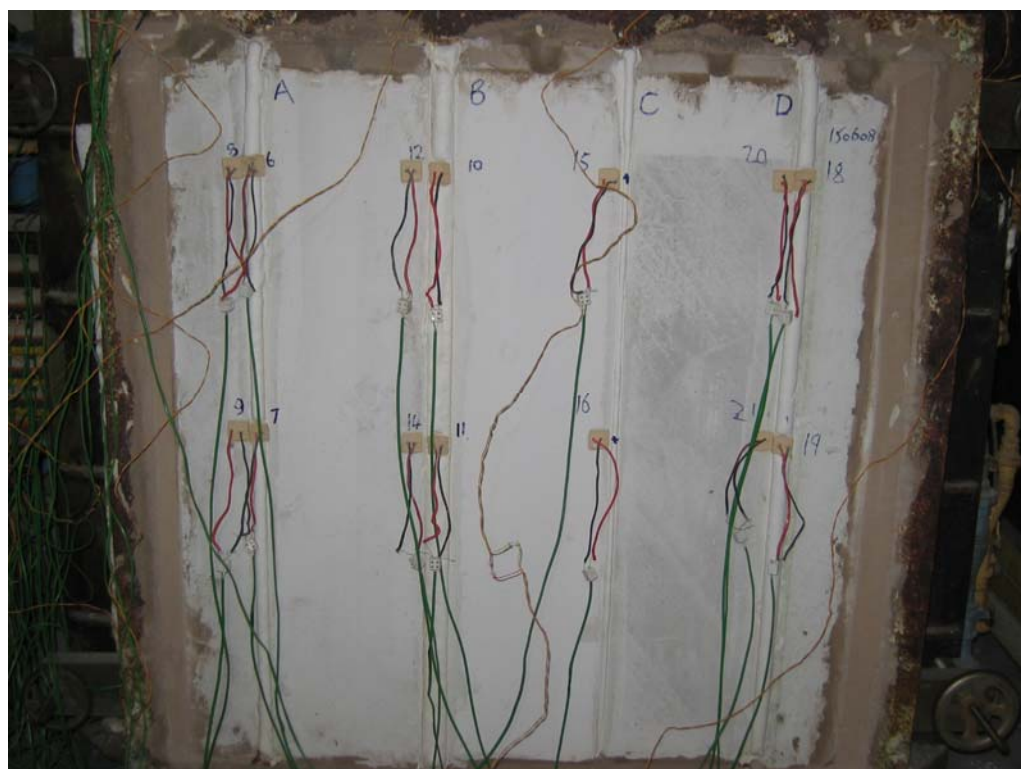
**The unexposed  
face of the wall  
construction  
after 120  
minutes of  
testing**

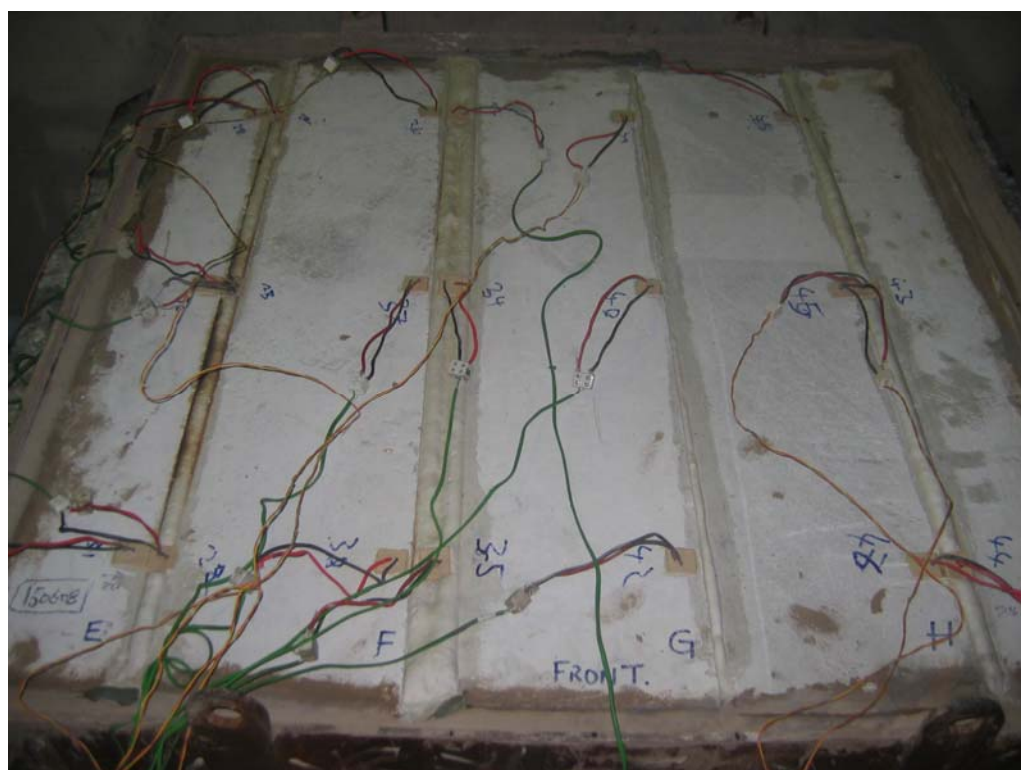
**The unexposed  
face of the floor  
construction  
after 120  
minutes of  
testing**

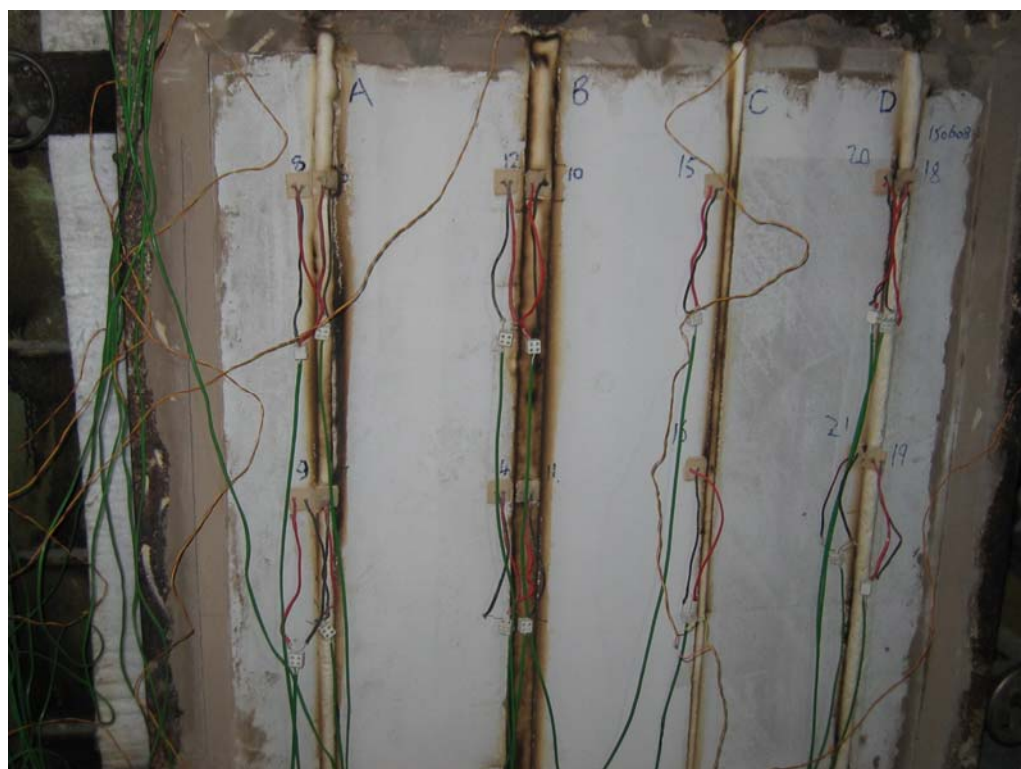
**The unexposed  
face of the wall  
construction  
after 240  
minutes of  
testing**

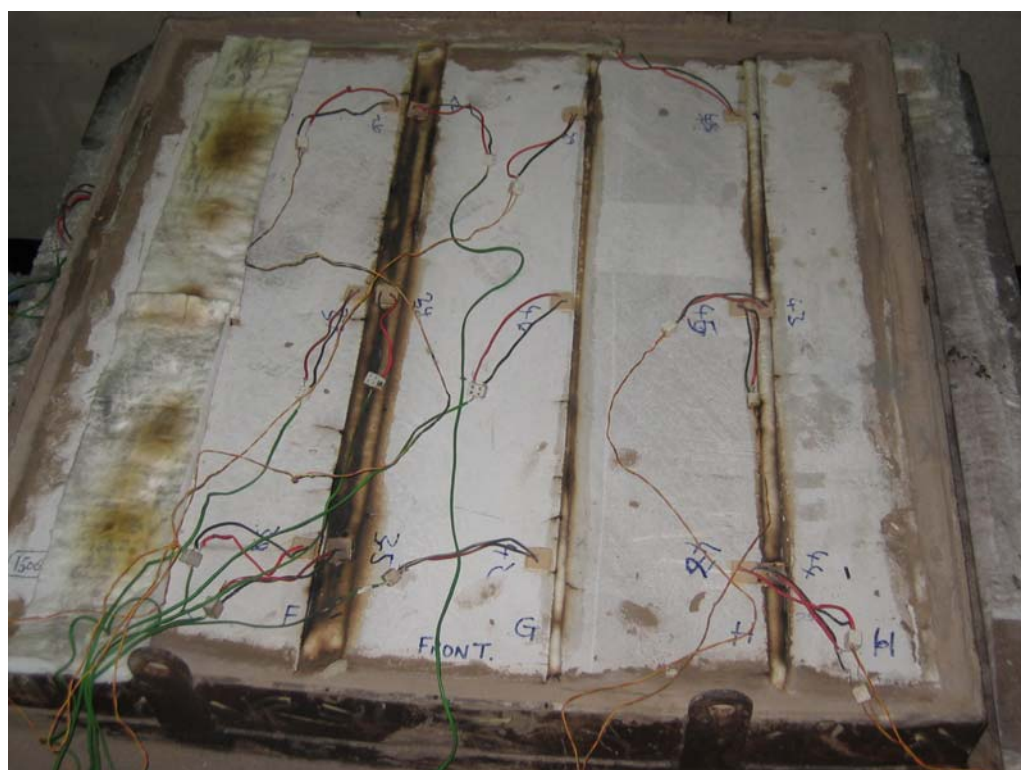
**The unexposed  
face of the floor  
construction  
after 240  
minutes of  
testing**

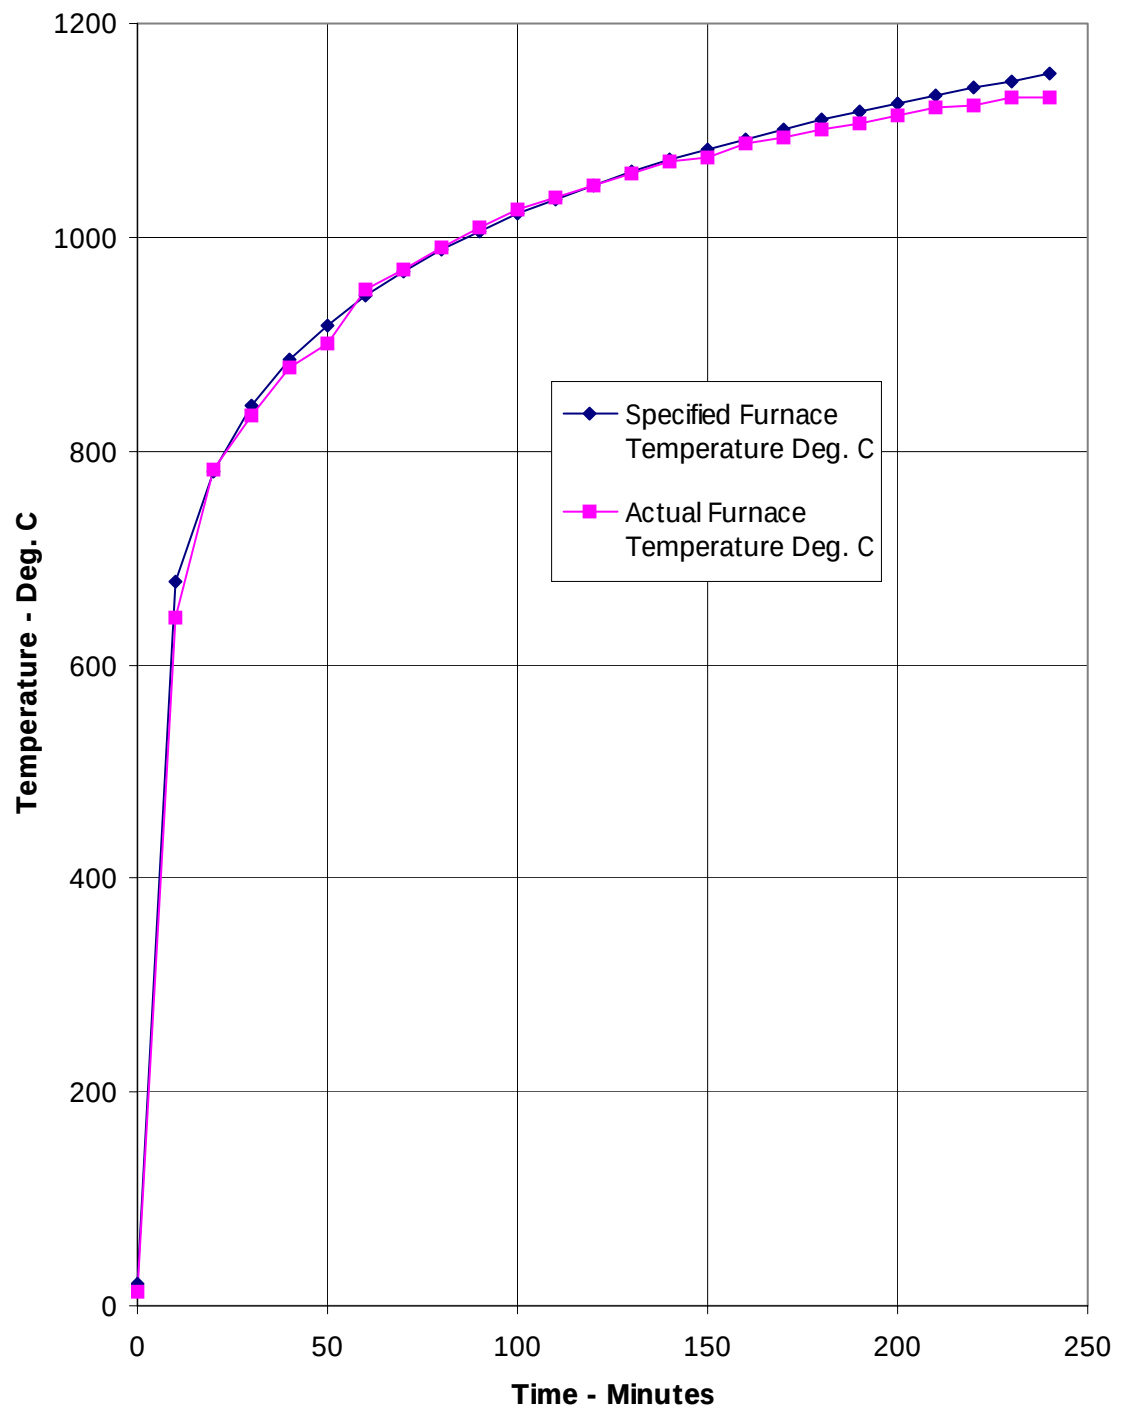
**Graph Showing Mean Furnace Temperature, Together With The Temperature/Time Relationship Specified In The Standard**

| <b>Furnace</b> | The furnace was controlled so that its mean temperature complied with the requirements of BS 476: Part 20: 1987, Clause 3.1, using four mineral insulated thermocouples distributed over a plane 100 mm from the surface of the wall construction. |
